Aviation Investigation Final Report

Location:	Peach Springs, Arizona	Accident Number:	WPR18MA087
Date & Time:	February 10, 2018, 17:19 Local	Registration:	N155GC
Aircraft:	Eurocopter EC130	Aircraft Damage:	Destroyed
Defining Event:	Loss of control in flight	Injuries:	5 Fatal, 2 Serious
Flight Conducted Under:	Part 135: Air taxi & commuter - Non-scheduled - Sightseeing

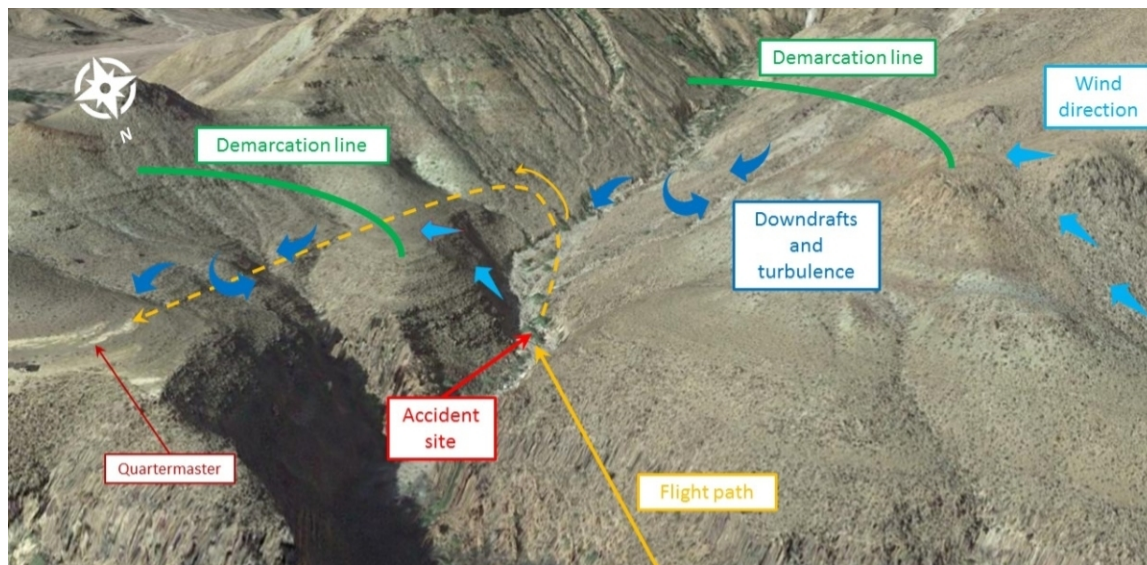
The landing site was located on a plateau and provided limited approach options due to its local topography. At the time of the accident, potential demarcation lines (boundaries of updrafts and downdrafts) would have been on the pinnacles of ridges located along the approach to the Quartermaster west pads. Figure 8 shows a conceptual illustration of potential demarcation lines and wind directions based on the terrain and wind environment present around the accident site at the accident time, and suggests areas where downdrafts, updrafts and turbulence could have impacted the accident flight's approach to the landing site.

Figure 8. Conceptual display of demarcation lines at accident site

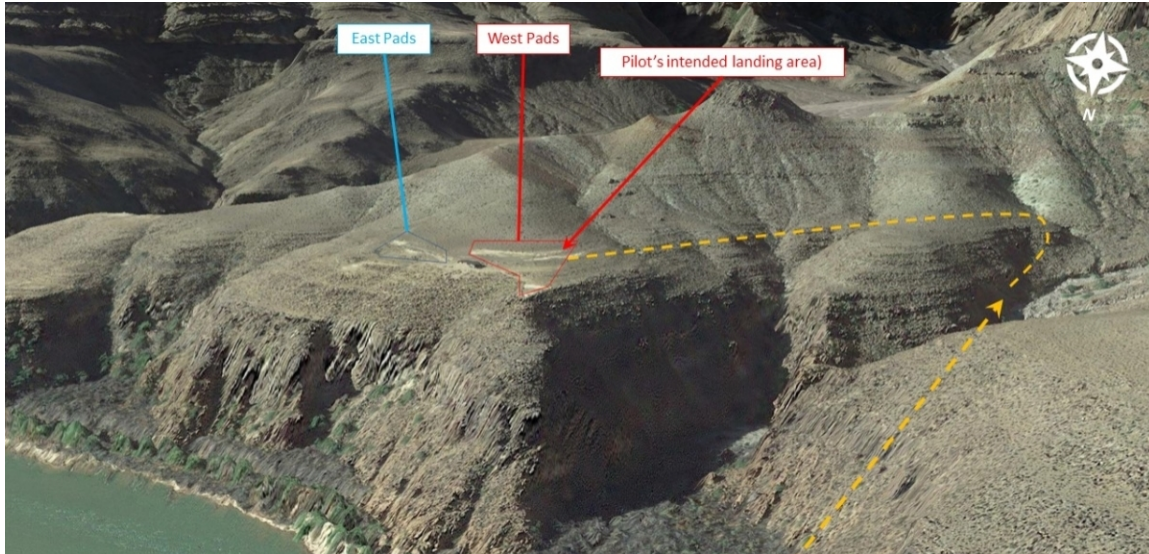
The pilot stated that he normally remained on the north side of the Colorado River, crossing the river between 200 and 300 ft above ground level (agl) while approaching Quartermaster for landing. After crossing the river, he entered a left turning descent toward the landing area. (See figure 1.) He stated

that, as he made the left turn, the helicopter encountered what he described as a “violent gust of wind” and began to spin, and as a result he was unable to maintain directional control.

Figure 1. Graphical representation of typical approach to west pads

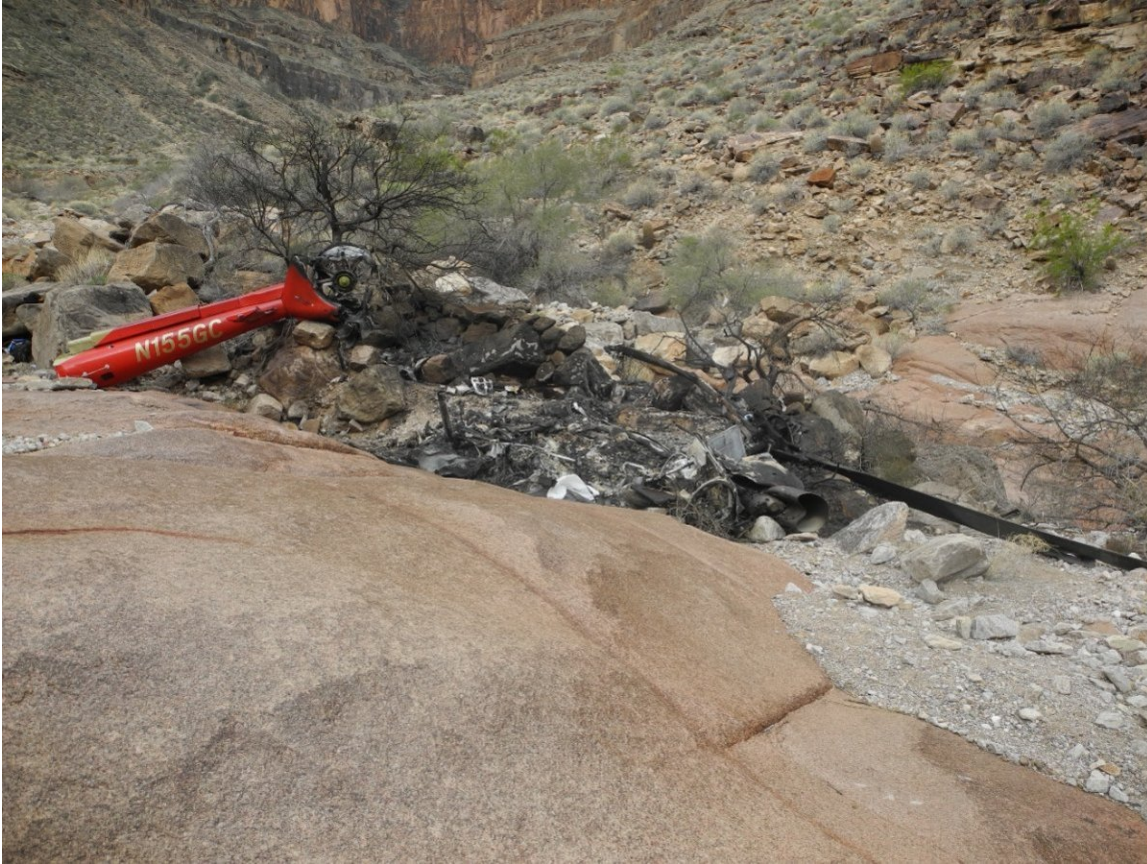
The helicopter came to rest upright in rocky terrain about 300 ft below the landing site on a heading of 222° magnetic. Most of the wreckage was consumed by the postcrash fire except for the tail boom and fenestron, which had separated from but were collocated with the fuselage. (See figure 3.) The engine, still attached to the engine deck, was found in the main wreckage and sustained fire damage. All three main rotor blades remained attached to the main rotor hub and exhibited damage consistent with high rotational energy. The tail stinger, fenestron hub cover, a toe from a skid step, and small pieces of transparent windshield were found on a canyon slope east of the main wreckage.

Figure 3. Photograph of accident site

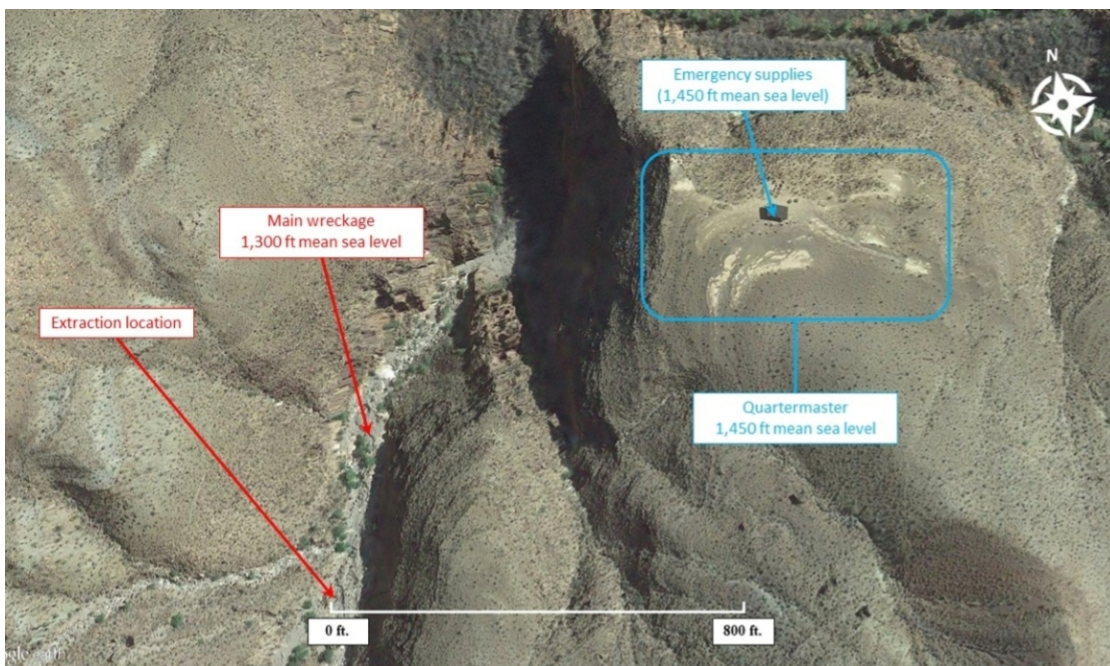
Numerous individuals, including pilots and passengers from other helicopters, were at Quartermaster at the time of the accident. Several Papillon pilots and members of the Royal Australian Air Force (RAAF) retrieved first aid kits from other helicopters and responded to the accident site, arriving about 20 minutes after the accident. They observed the burning helicopter and the pilot and three seriously injured passengers who were outside the helicopter. (See figure 5.)

Figure 5. Quartermaster landing zone, accident site, and extraction location

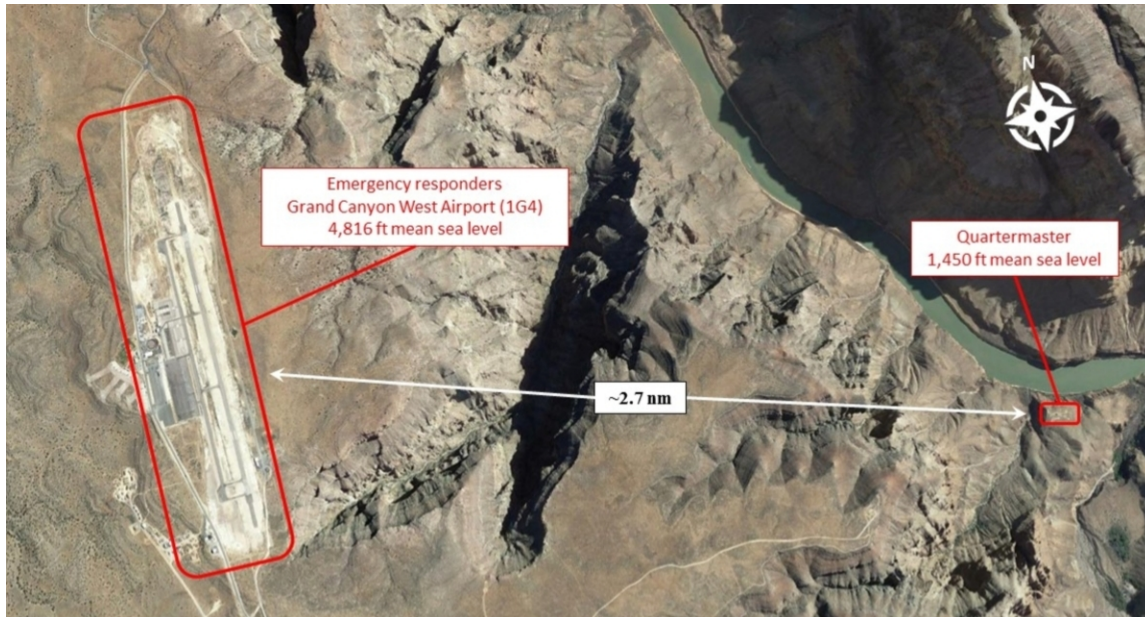
The location of the accident site posed significant challenges and extended the response time for emergency personnel, who had to be flown in by helicopter. (See figure 6.) These first responders reached the accident site about 45 minutes after the accident.

Figure 6. The location and terrain elevation difference between first responders at Grand Canyon West Airport and Quartermaster
