# Aviation Investigation Final Report

<b>Location:</b>	Coalinga, California	<b>Accident Number:</b>	WPR20LA280
<b>Date &amp; Time:</b>	August 19, 2020, 09:45 Local	<b>Registration:</b>	N711GH
<b>Aircraft:</b>	Arrow-Falcon Exporters, Inc. UH-1H	<b>Aircraft Damage:</b>	Destroyed
<b>Defining Event:</b>	Loss of control in flight	<b>Injuries:</b>	1 Fatal
<b>Flight Conducted Under:</b>	Public aircraft

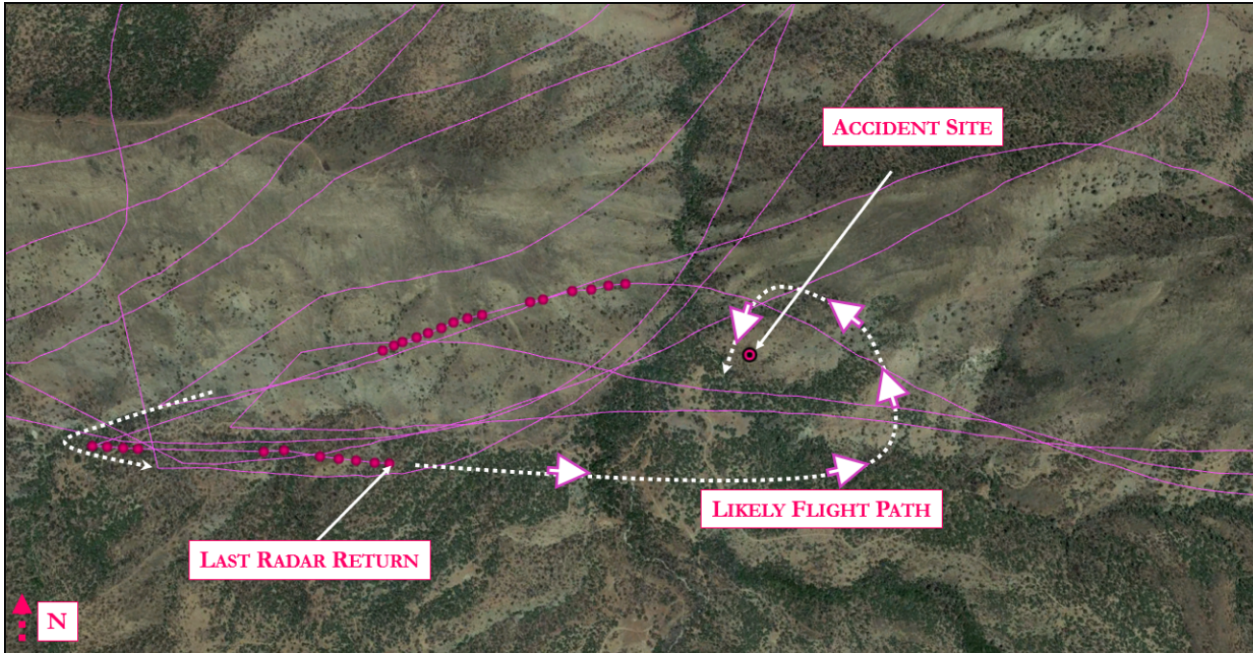
Figure 1: Radar Data

The Bell 212 pilot recalled that after he departed the dip site with a bucket of water, he heard the accident pilot communicate over the air-to-air radio that he felt "abnormal noises and vibrations" and that he was going to make a precautionary landing. The Bell 212 pilot dumped his water and caught up to the accident helicopter with the intention of assisting the pilot in finding a good area to land. He remained a few hundred feet behind and above the accident helicopter. The accident helicopter was about 1,000 ft above ground level and maneuvering at an airspeed between 60 to 70 kts. The accident pilot then stated that the helicopter's "temps and pressures are good." A few seconds later the accident pilot stated "it's my hydraulics." The Bell 212 pilot relayed that he should make a right turn and fly down the ravine to less mountainous terrain (the flats).

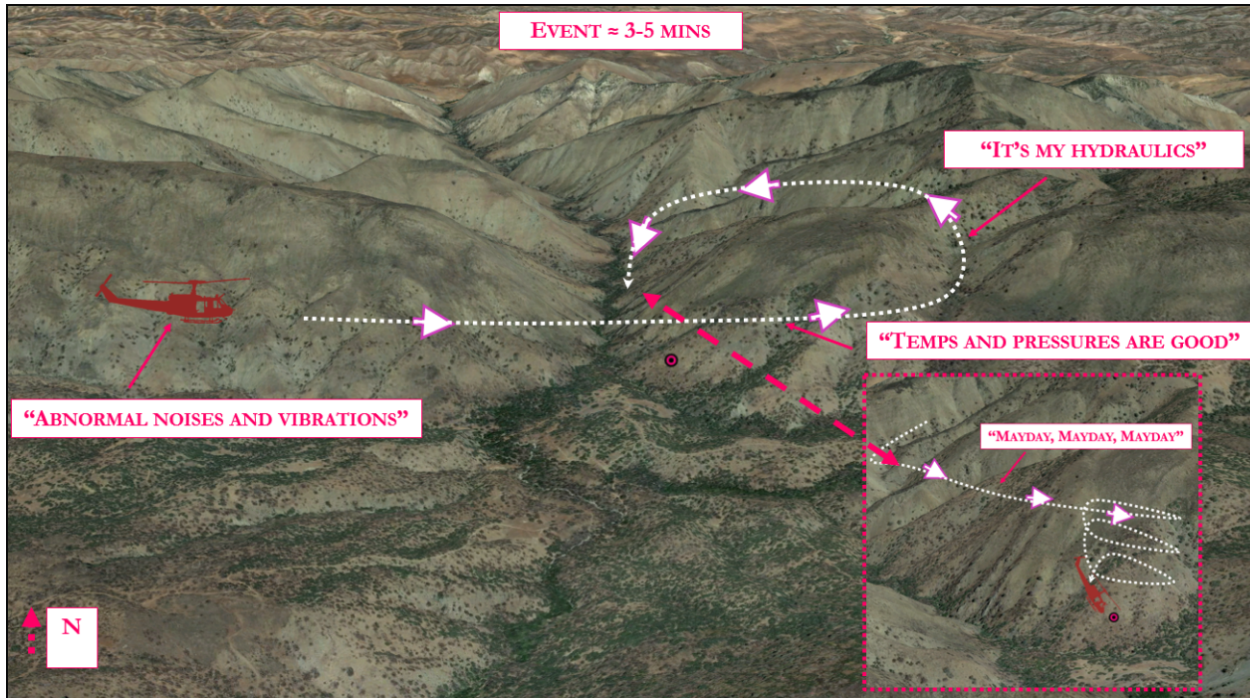
Figure 2: Pilot's Statements Prior to Accident

The helicopter started to make a right turn and then banked back to the left while losing airspeed. The Bell 212 pilot noticed the helicopter still had its 100 ft longline and external load bucket attached and told the accident pilot to "release your long line and get forward airspeed," The accident pilot then stated "Mayday, Mayday, Mayday." The left turn steepened remaining in a level pitch attitude, and the helicopter began to make three or four 360° rotations (rapidly swapping the front and back), while drifting north-east. The helicopter then pitched in a nose-low, near vertical attitude and collided into terrain (see figure 2 below). A fire immediately erupted and the Bell 212 pilot made multiple trips to the dip site to fill his bucket and drop water on the accident site.
